FLOOD PLAIN MANAGEMENT STUDY

LOWER WOOD RIVER

Buffalo and Hall Counties, Nebraska

FEBRUARY 1990

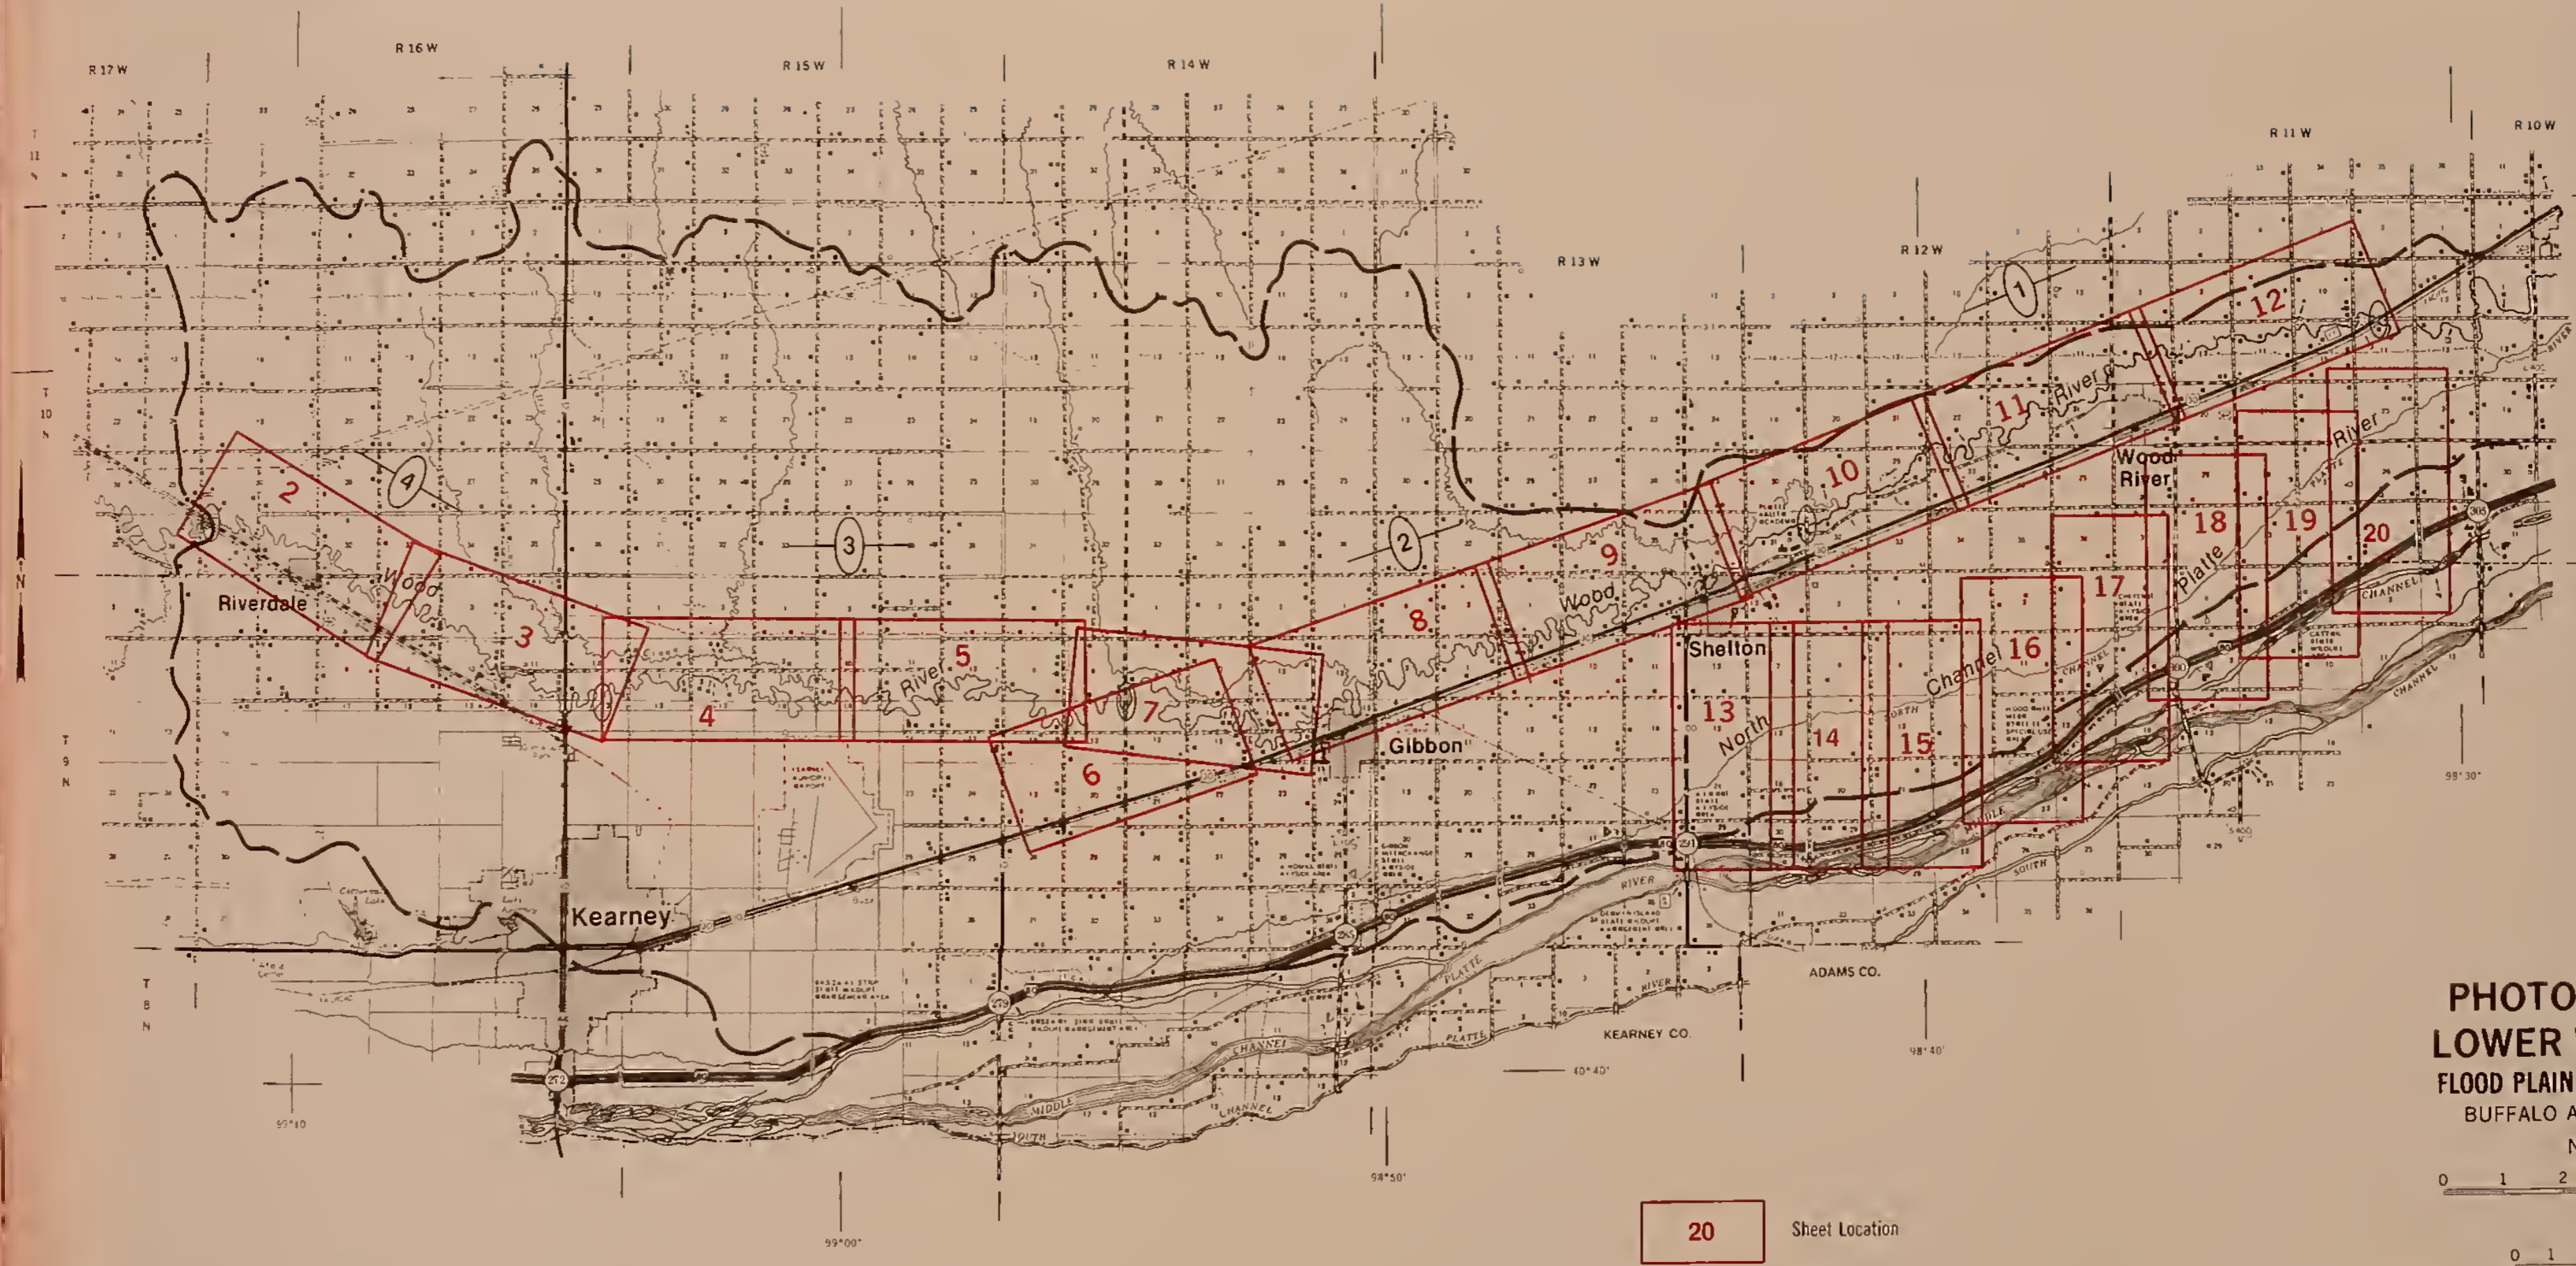
PHOTO MAP INDEX
LOWER WOOD RIVER
FLOOD PLAIN MANAGEMENT STUDY
BUFFALO AND HALL COUNTIES
NEBRASKA

20 Sheet Location

4 Evaluation Reach

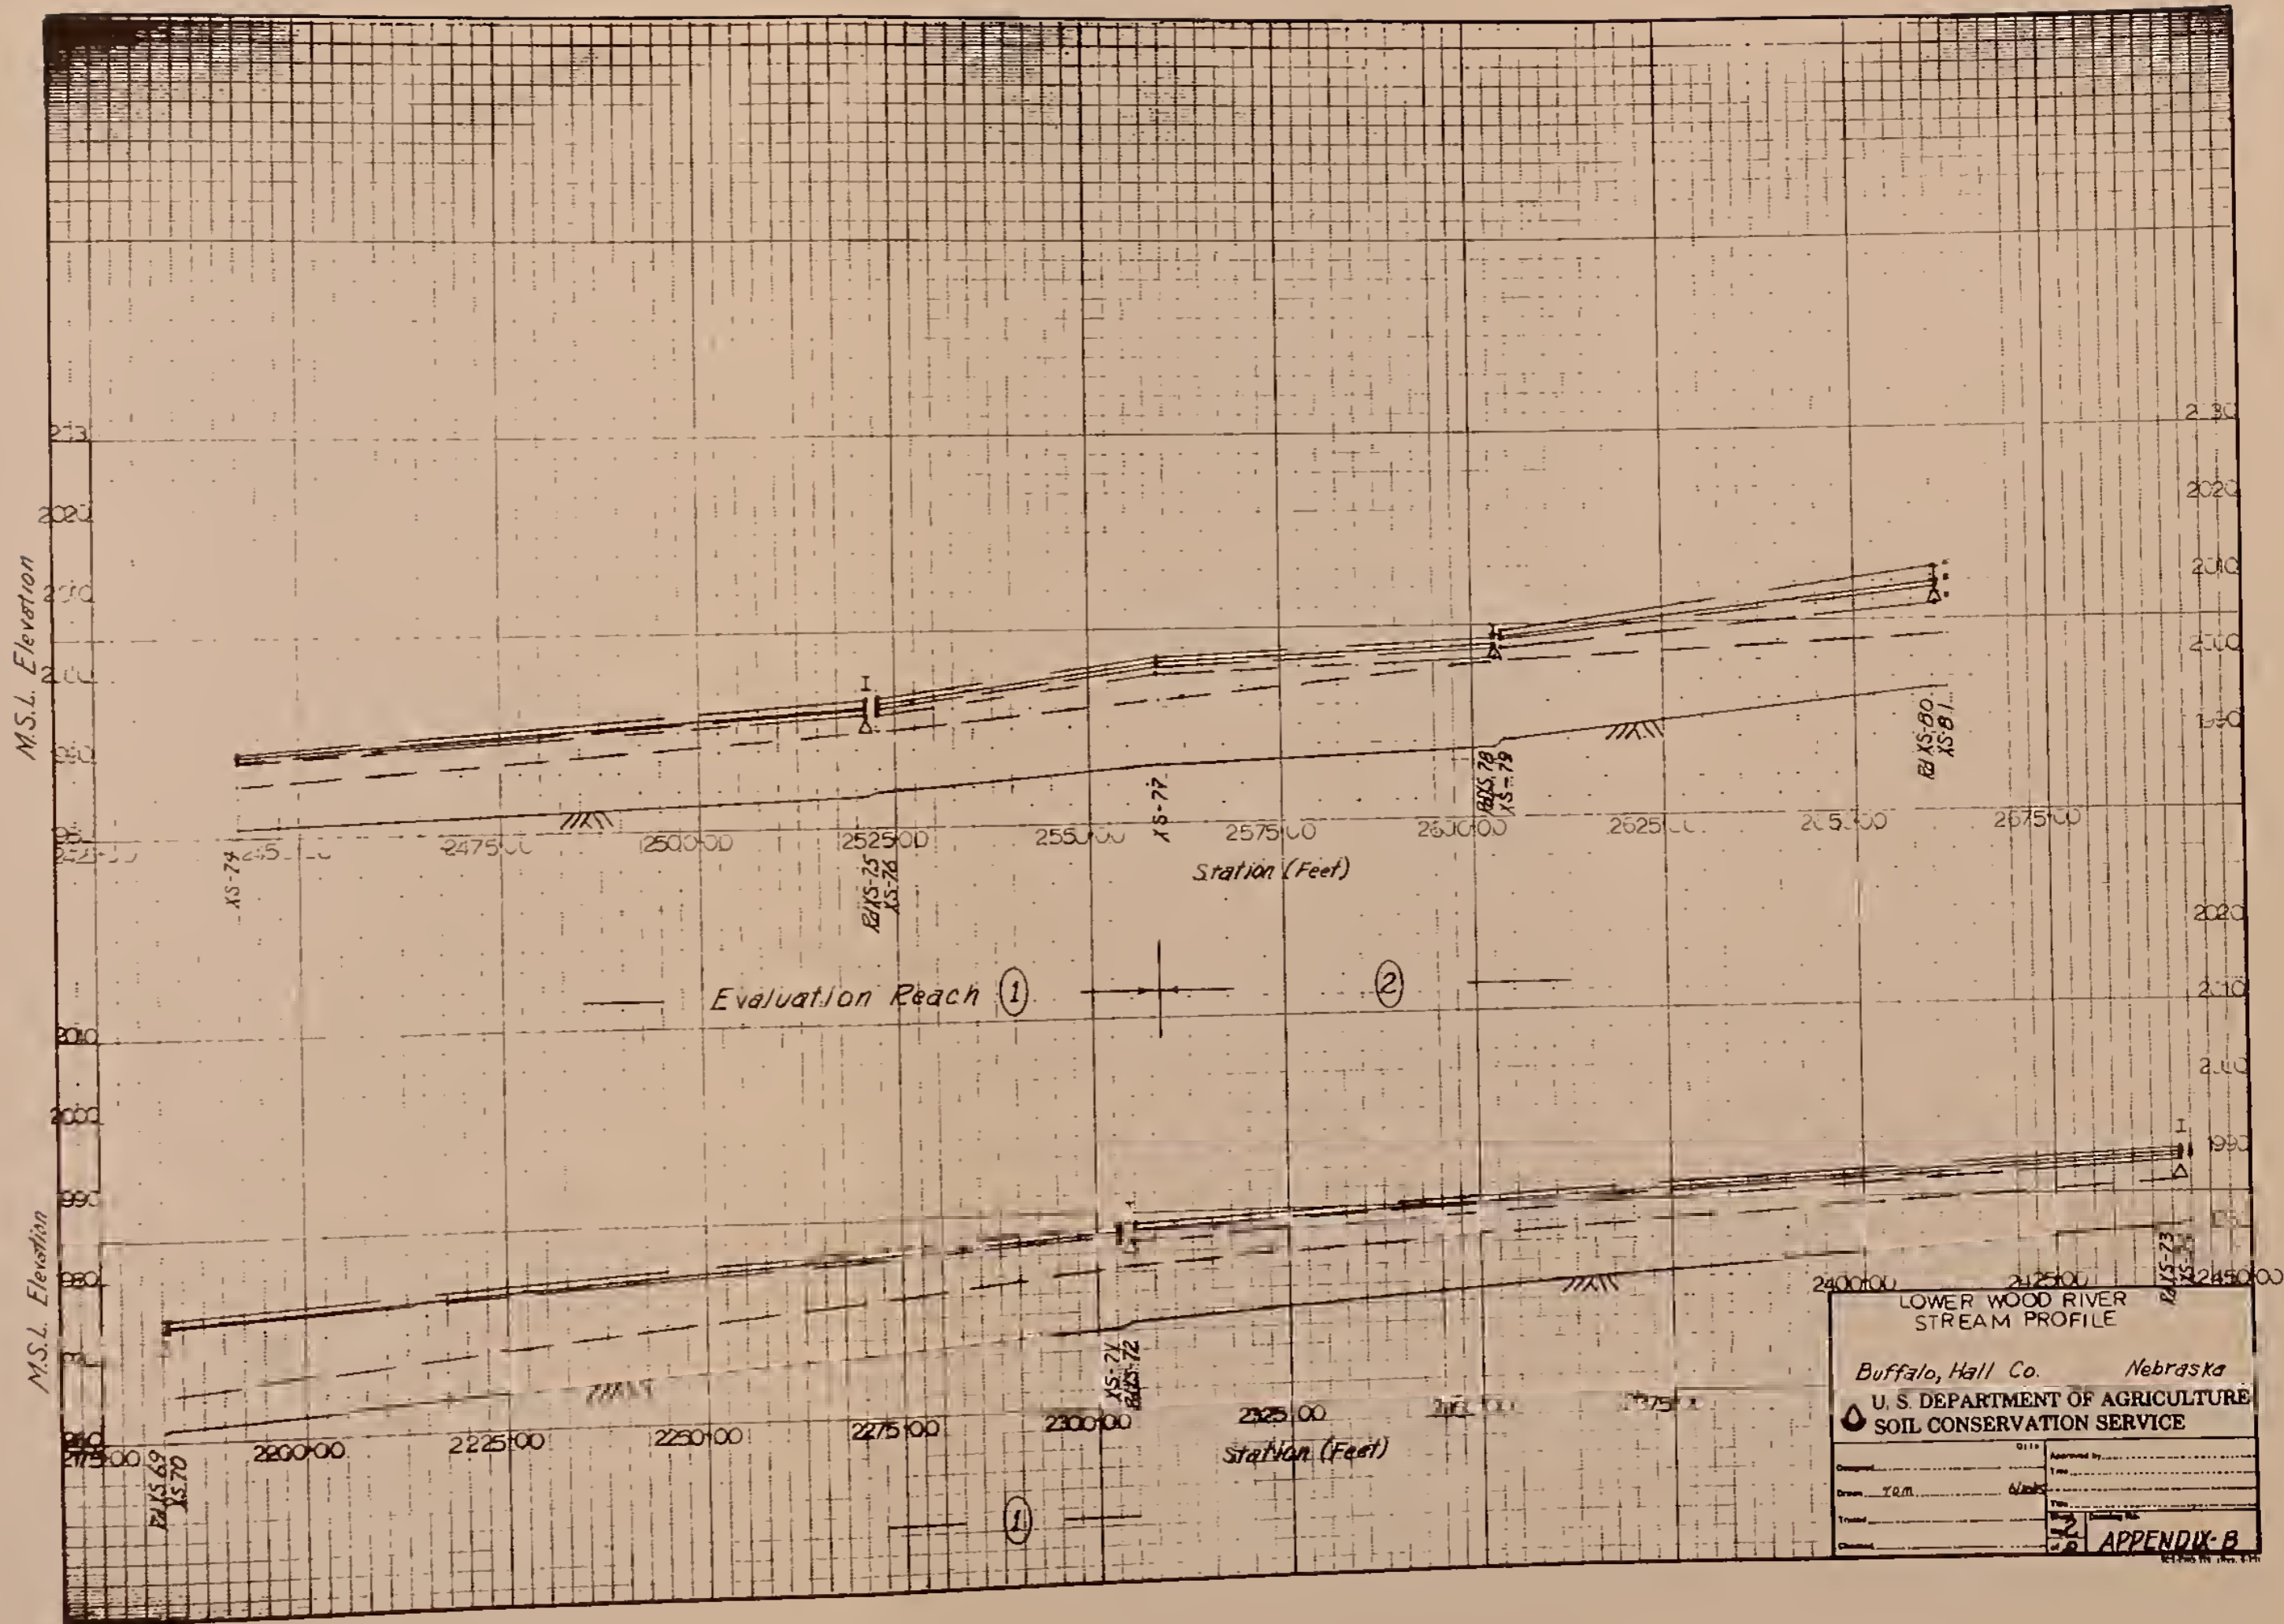
LOWER WOOD RIVER
STREAM PROFILE

- LEGEND
- Year _____
 - 500 _____
 - 100 _____
 - 50 _____
 - 10 _____
 - Low Bank _____
 - Channel Bottom
 - Bridge
 - Low Point In Roadway
 - Evaluation Reach

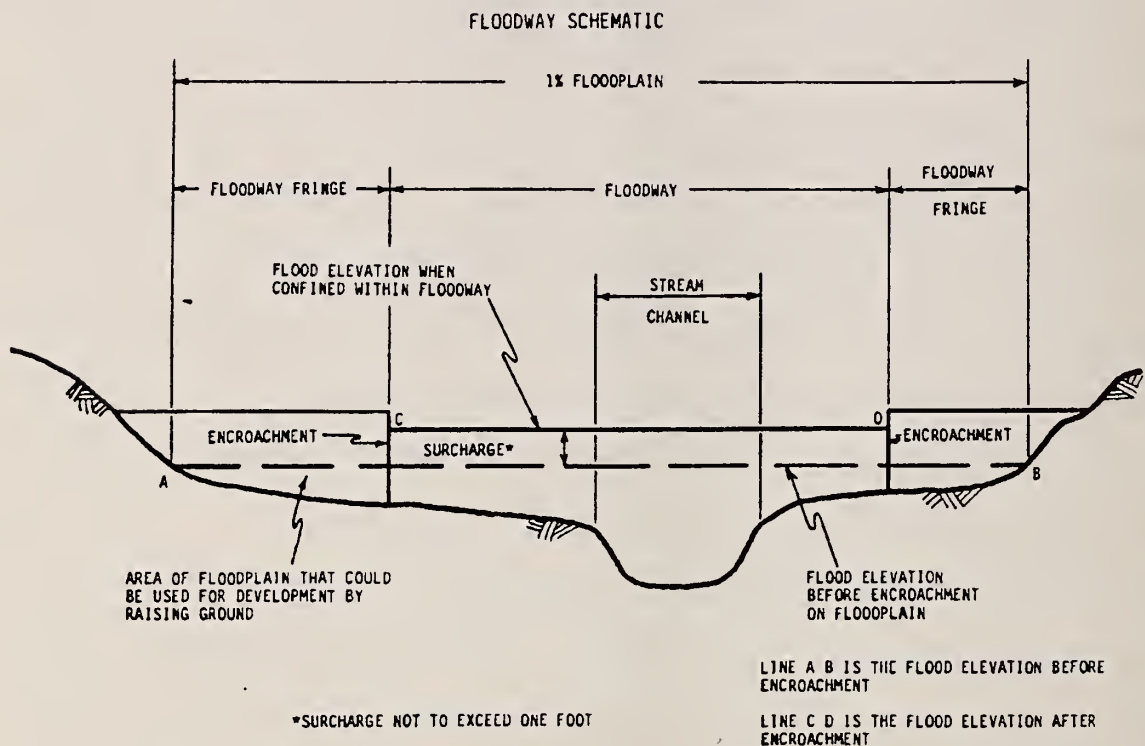
Figure 3

The area between the floodway and boundary of 1% recurring flood is termed the floodway fringe. The floodway fringe thus encompasses the portion of the floodplain that could be completely obstructed without increasing the water surface elevations of the 1% flood more than 1 foot at any point. The typical relationship between the floodway fringe and the floodway are shown in the floodway schematic (Figure 3).

Uses of the floodway are allowable providing they do not restrict flow in any way causing an increase in flow depths. Also no structure for human habitation is permitted in the floodway. Any use of the fringe area is permissible, provided any structure in the fringe area must have its first floor elevation one foot above the 1% recurrence interval flood elevation.

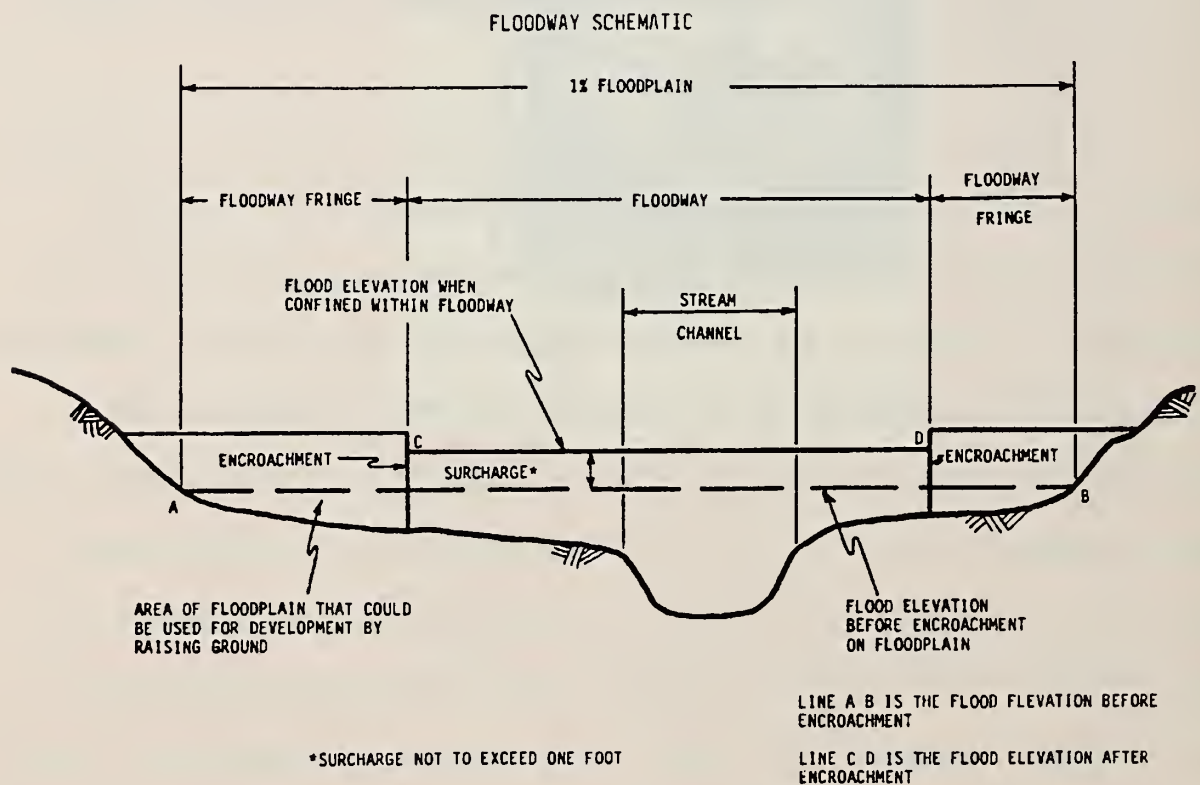
The area between the floodway and boundary of 1% recurring flood is termed the floodway fringe. The floodway fringe thus encompasses the portion of the floodplain that could be completely obstructed without increasing the water surface elevations of the 1% flood more than 1 foot at any point. The typical relationship between the floodway fringe and the floodway are shown in the following schematic.

Uses of the floodway are allowable providing they do not restrict flow in any way causing an increase in flow depths. Also no structure for human habitation is permitted in the floodway. Any use of the fringe area is permissible, provided any structure in the fringe area must have its first floor elevation one foot above the 1% recurrence interval flood elevation.

in flood heights. The Nebraska Department of Water Resources has defined that the floodway be determined using no more than a 1 foot surcharge. The 1 foot surcharge floodway proposed for this study was computed by equal conveyance reduction from each side of the floodplain.

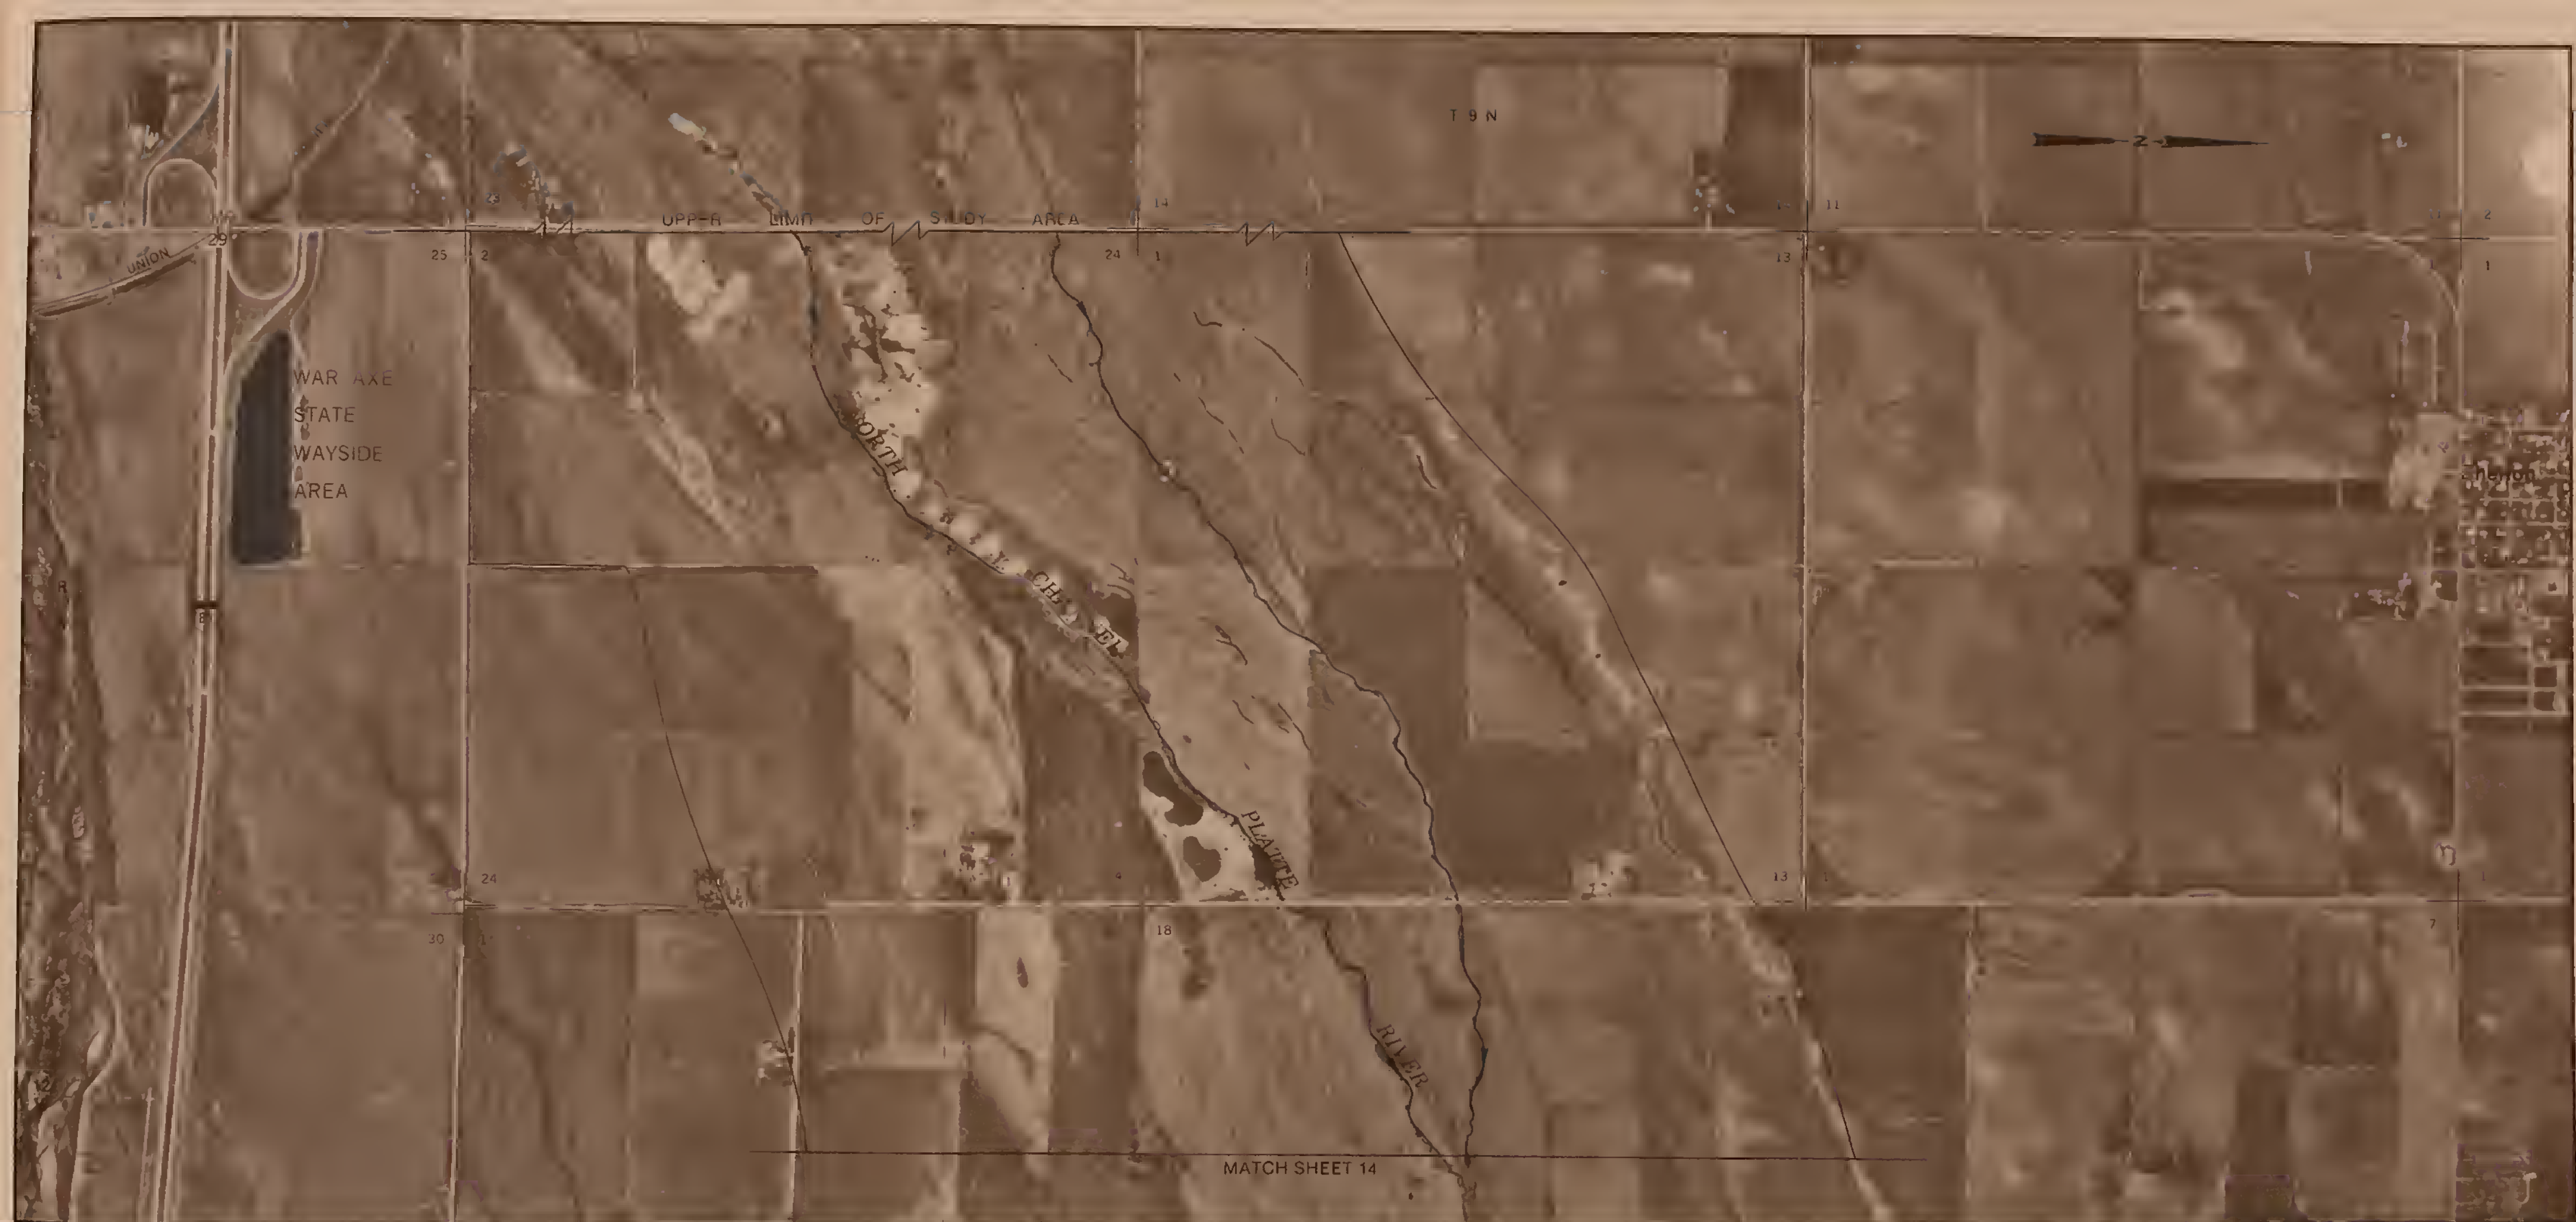
**SHEET
12 OF 20**

NOTE: LIMITS OF FLOODING SHOWN MAY VARY FROM ACTUAL LOCATIONS ON THE GROUND AND DUE TO INHERENT AERIAL PHOTOGRAPHIC DISPLACEMENT THE PHOTOGRAPHIC IMAGE MAY VARY FROM TRUE GROUND LOCATION

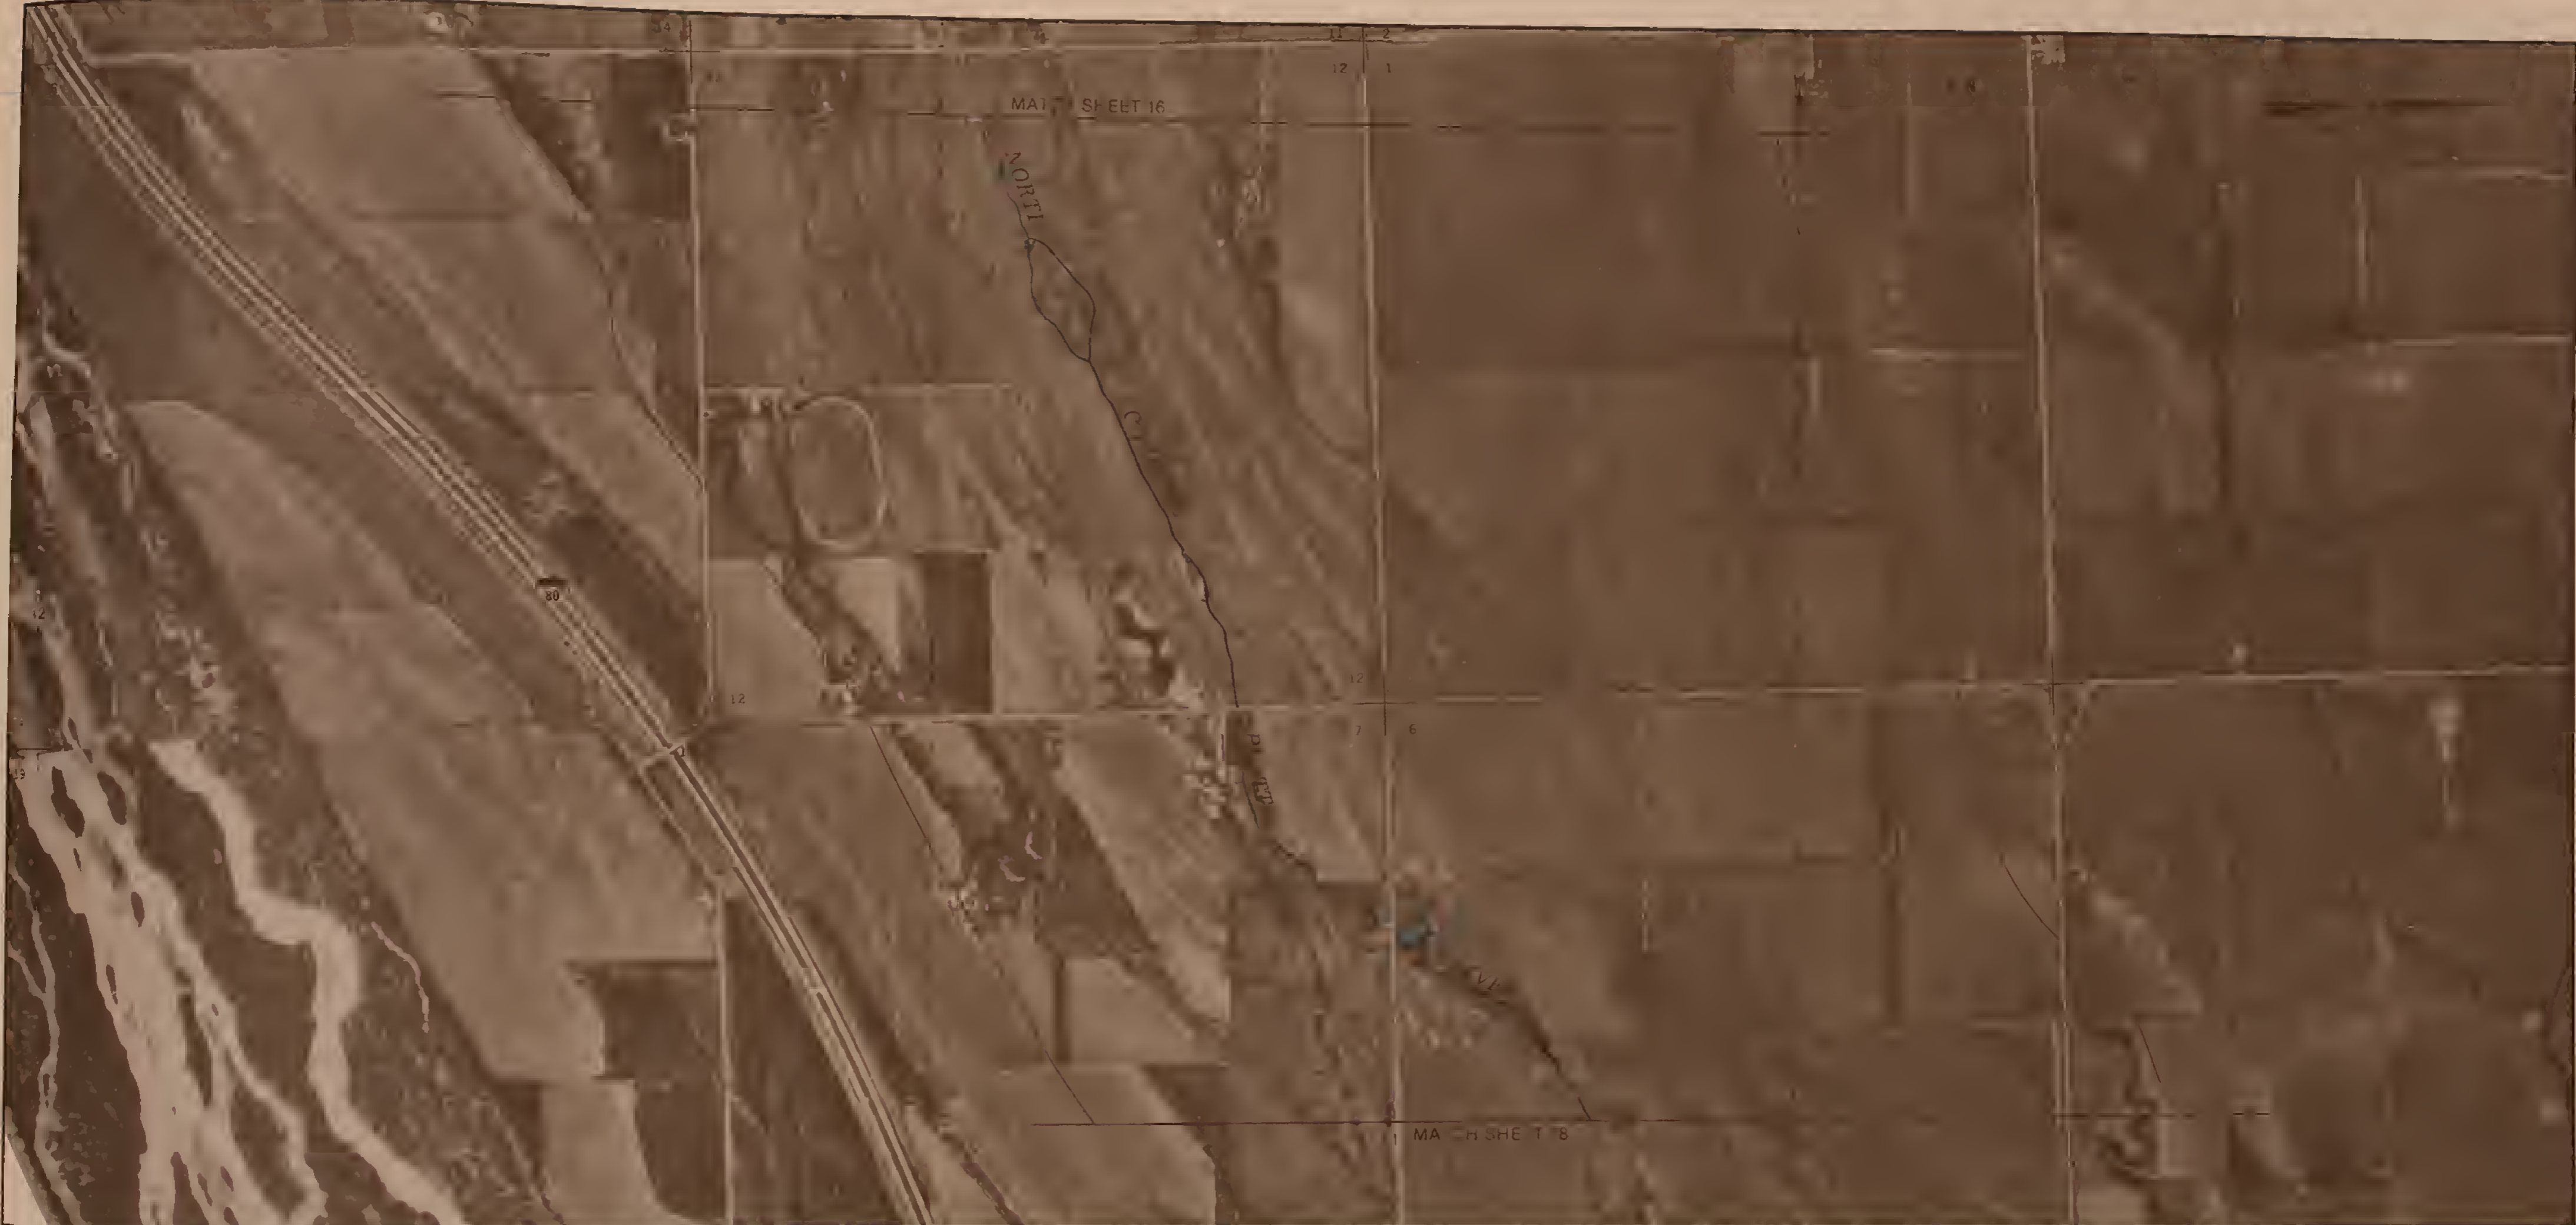
SHEET
16 OF 20
AUGUST 1989 1002444

NOTE: LIMITS OF FLOODING SHOWN MAY VARY FROM ACTUAL LOCATIONS ON THE GROUND AND DUE TO INHERENT AERIAL PHOTOGRAPHIC DISPLACEMENT THE PHOTOGRAPHIC IMAGE MAY VARY FROM TRUE GROUND LOCATION

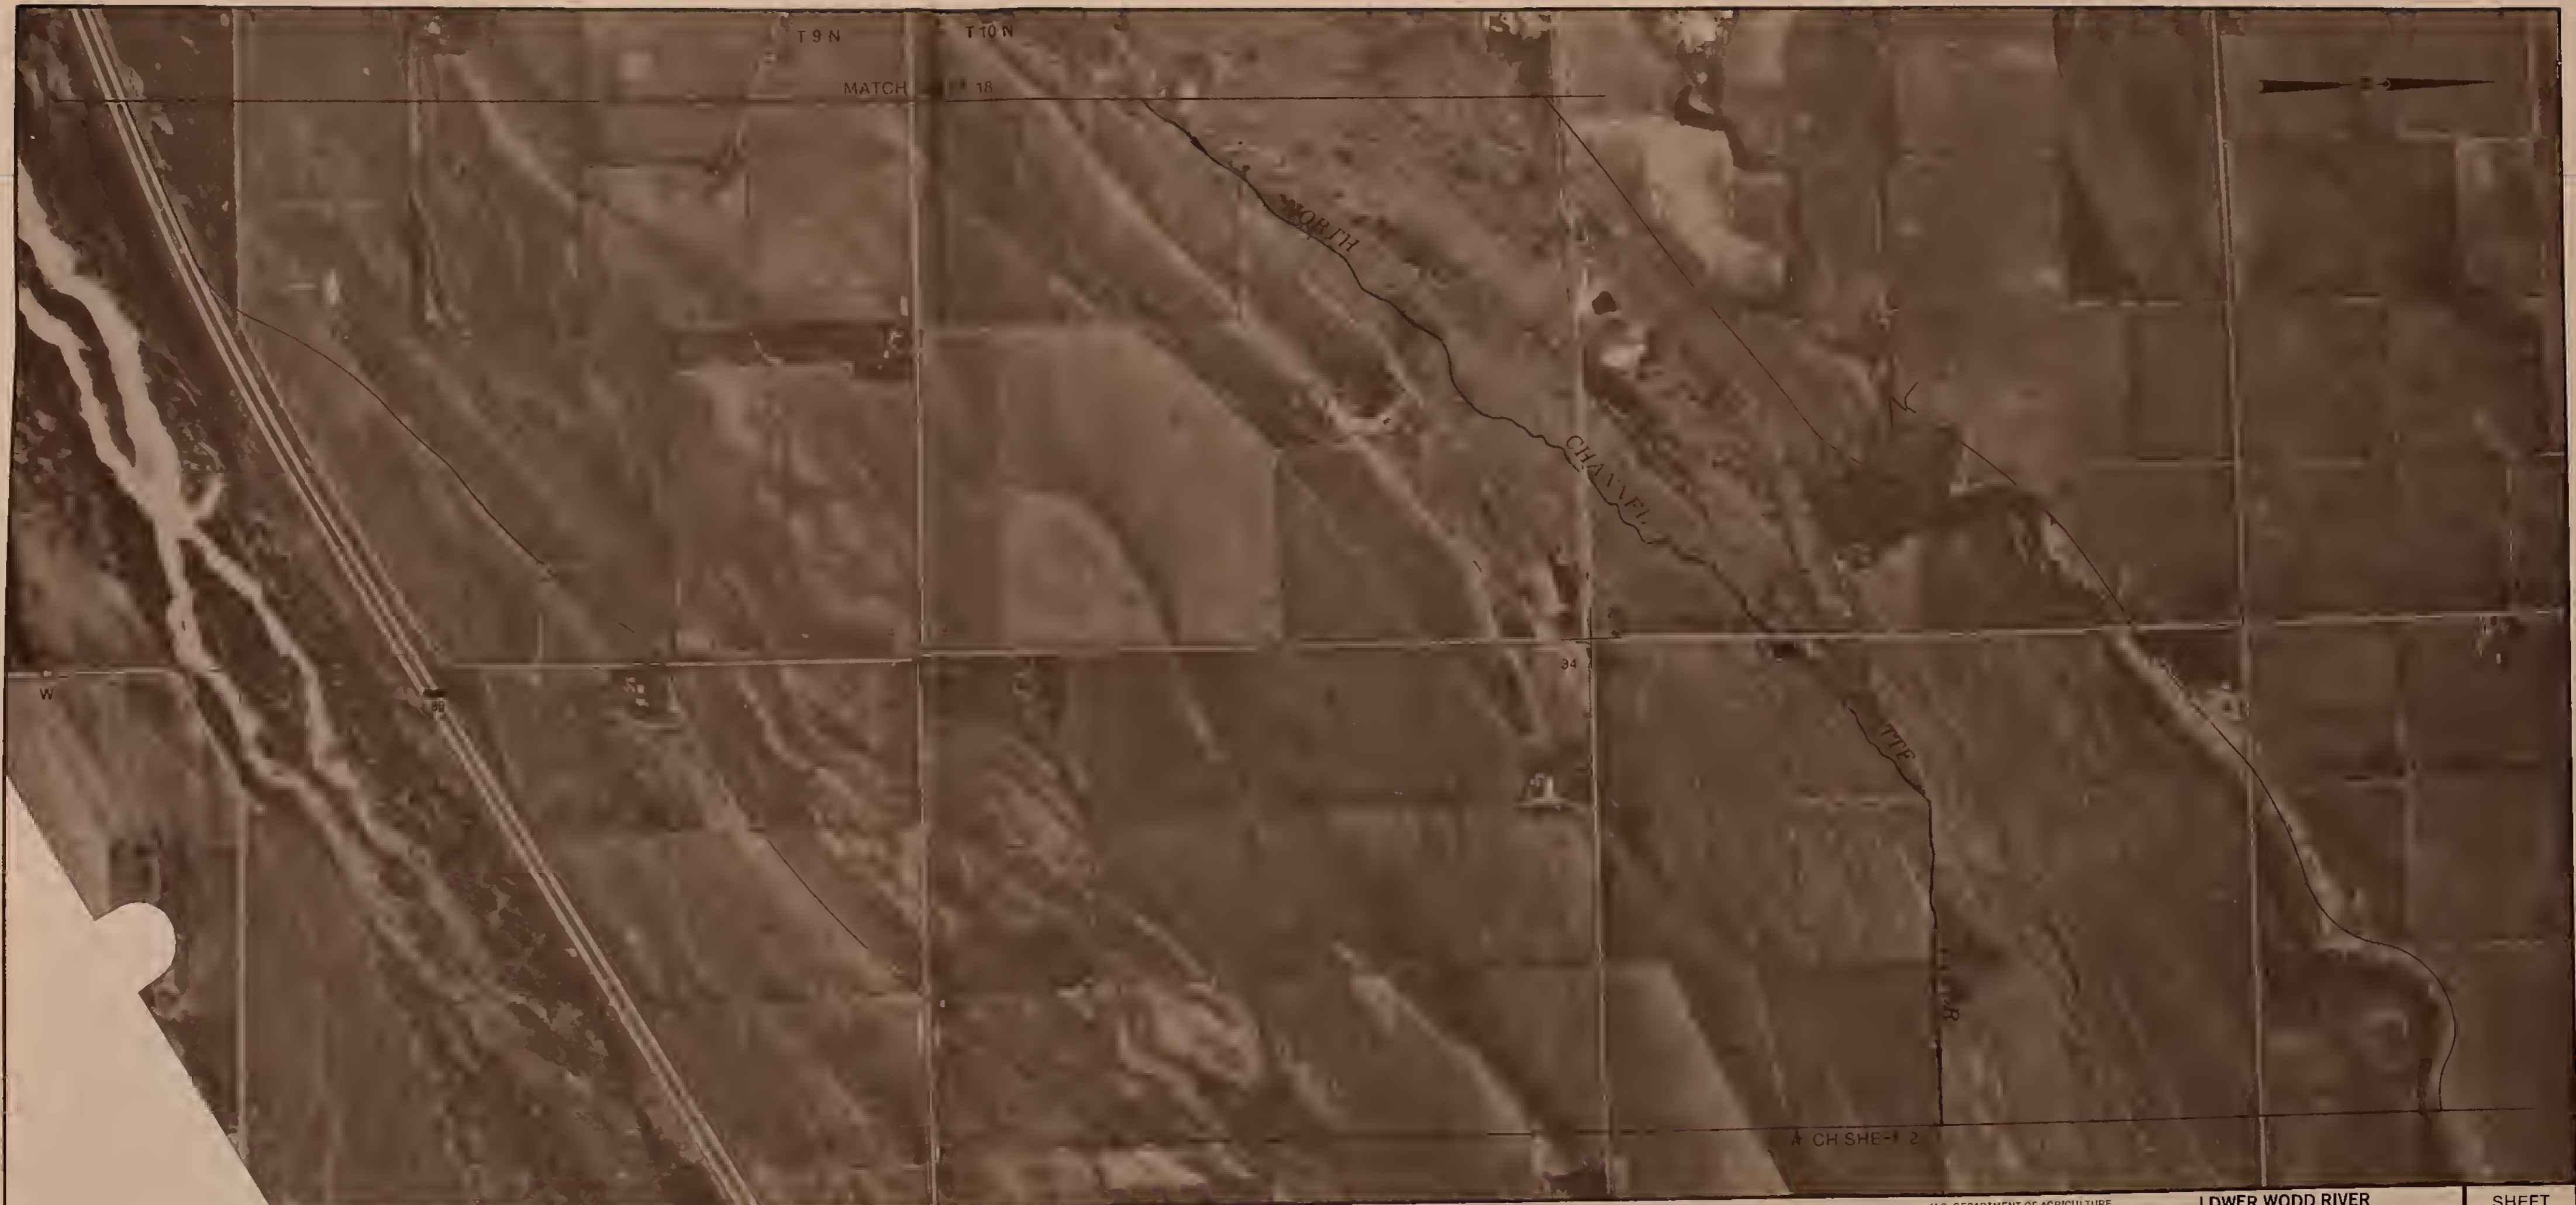
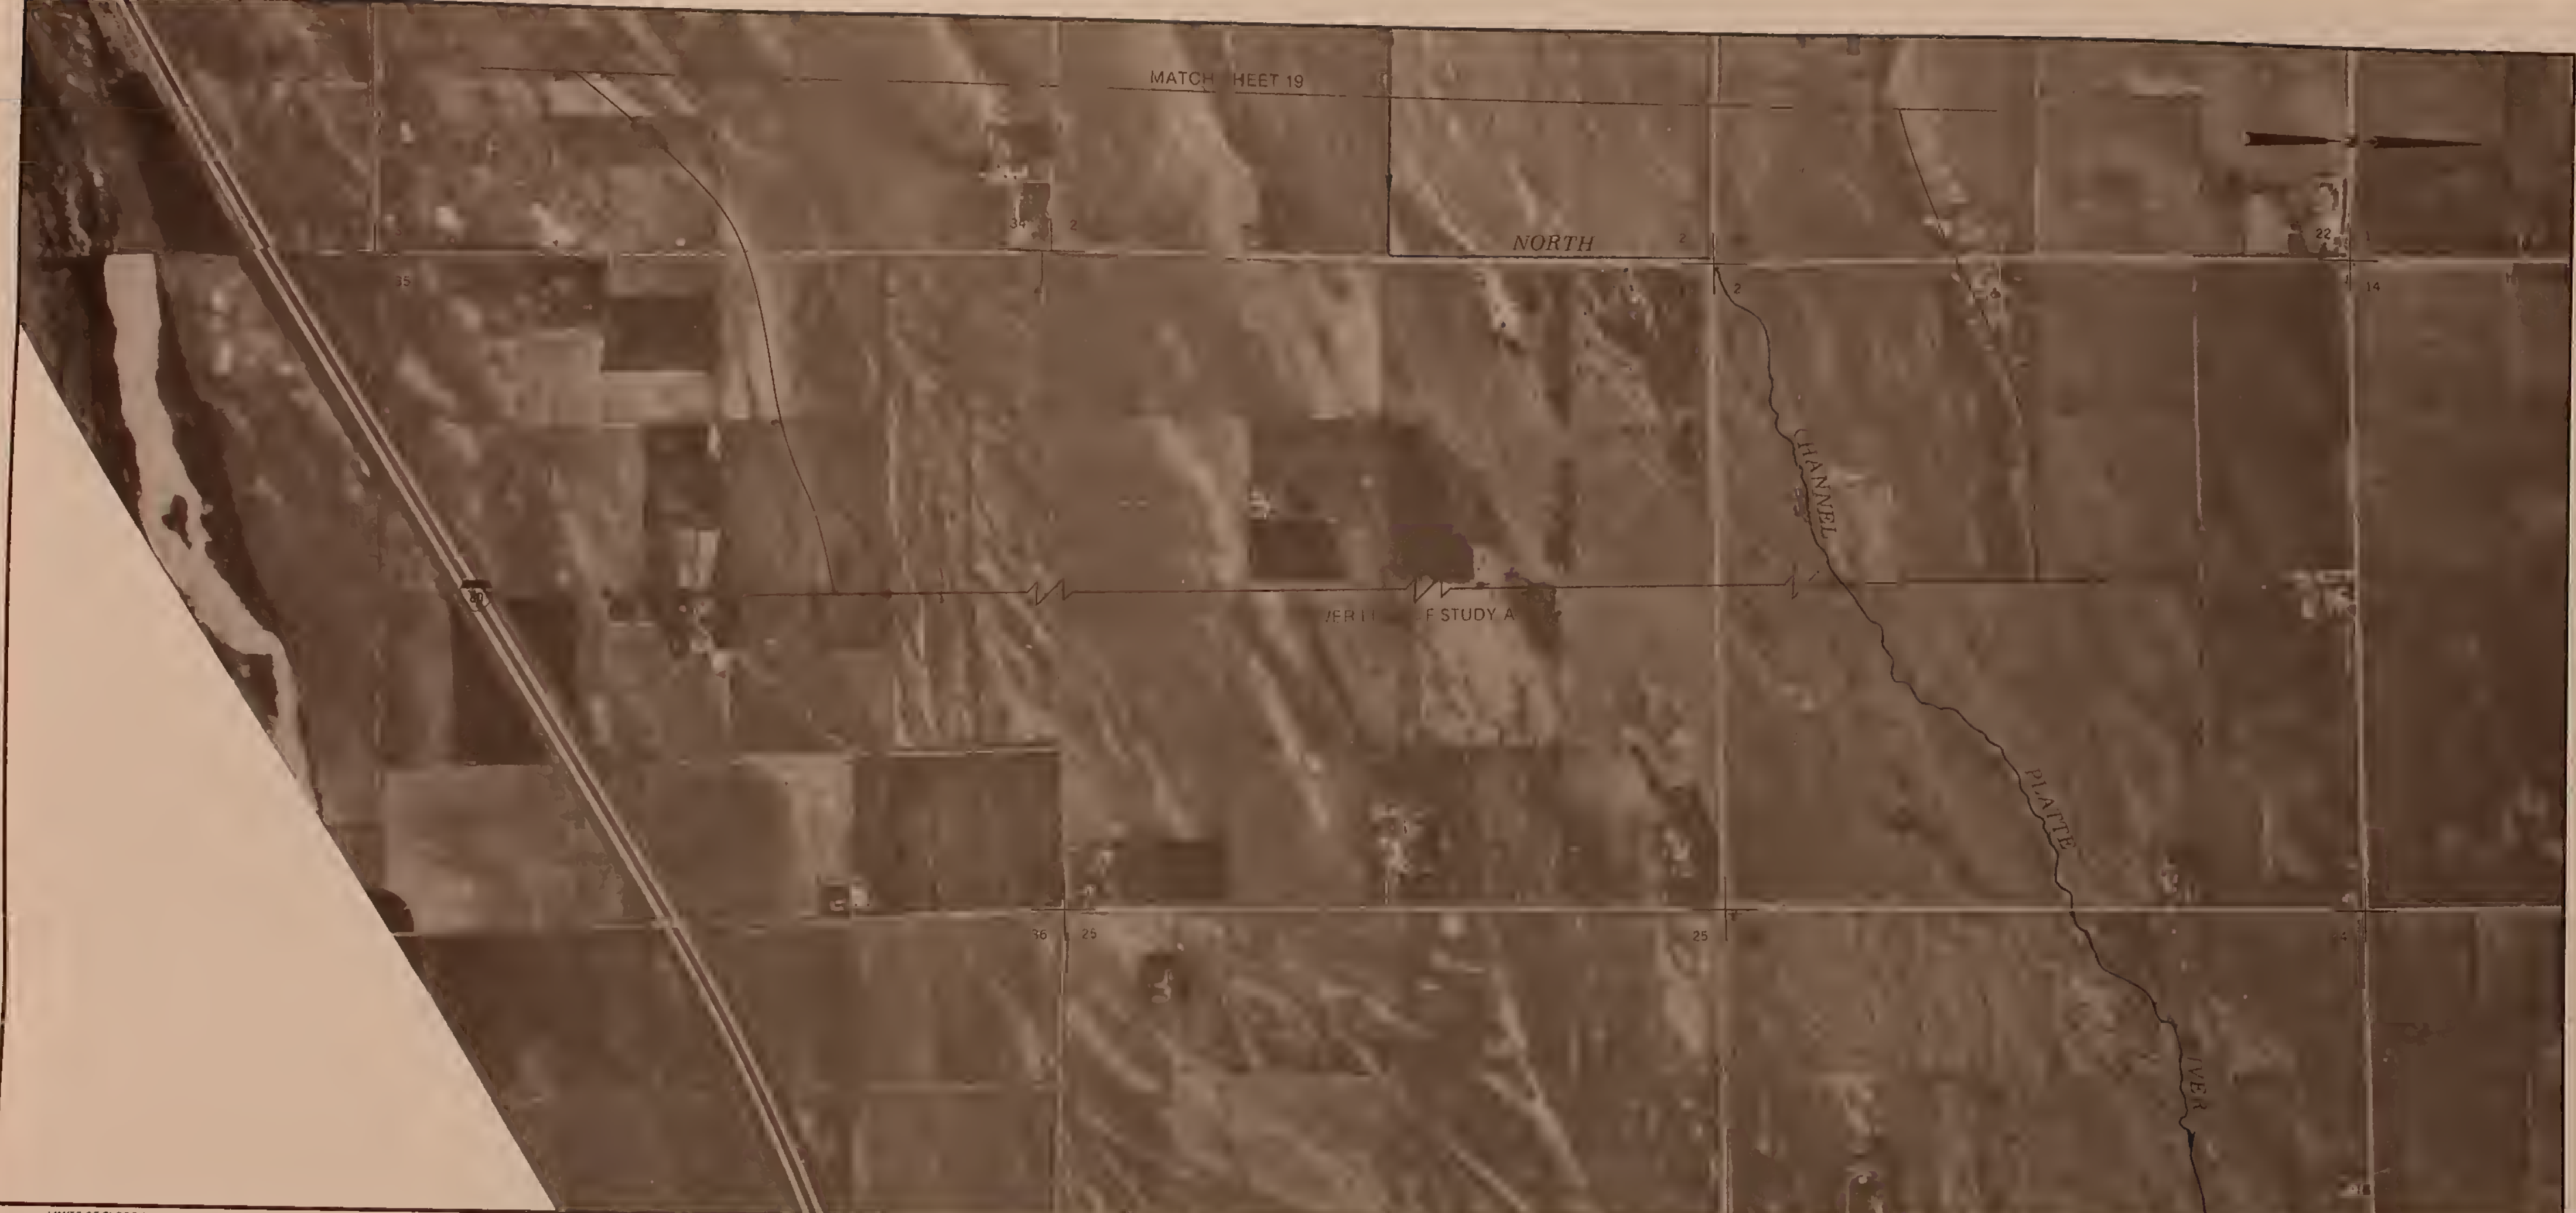
SHEET
18 OF 20

NOTE: LIMITS OF FLOODING SHOWN MAY VARY FROM ACTUAL LOCATIONS ON THE GROUND AND DUE TO INHERENT AERIAL PHOTOGRAPHIC DISPLACEMENT THE PHOTOGRAPHIC IMAGE MAY VARY FROM TRUE GROUND LOCATION
